## BENTLEY CYLINDER HEAD GASKET RENEWAL

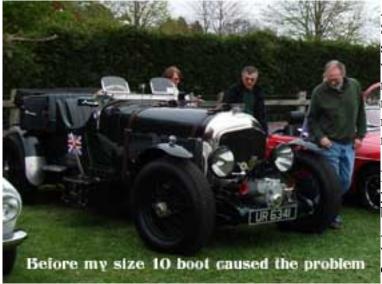
Getting ready for lift off

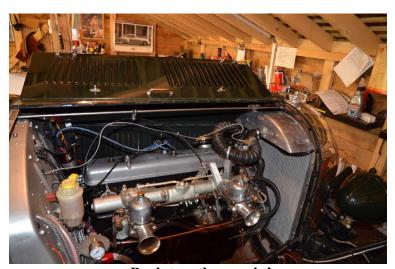
Back together again!
